**Atlantic Shore Line**  
**Locomotive 100**  
Curatorial Report no. 3  
17 January – 5 February 2007  
*by Donald G. Curry, Interim Shop Manager*  
Seashore Trolley Museum

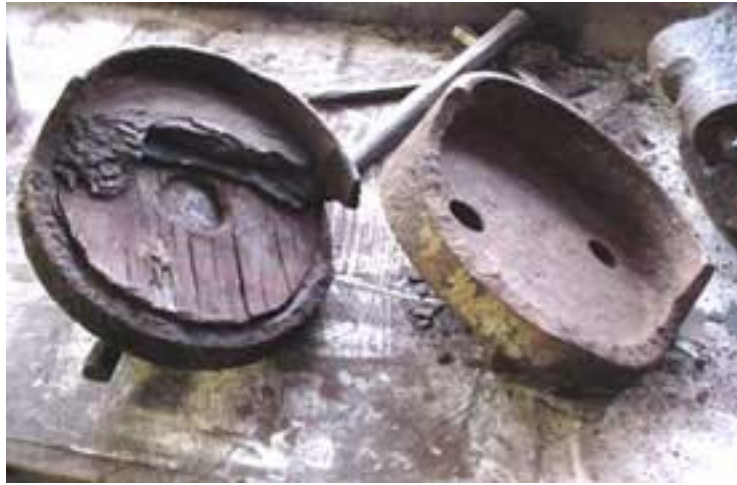
Five of the eight equalizer coil spring ‘cups’ were badly cracked, with over half the outside rim missing. In the bottom of these cast iron ‘cups’ are two one-inch diameter holes which were supposed to let water drain out. For whatever reason, YUCo added shimming under the springs, the first of which was a  $\frac{3}{8}$  in. thick red oak disc. On top of that they placed several steel discs. The oak has a very corrosive effect on steel which helped rust the discs but, more seriously, it sealed the drain holes as it swelled, thus allowing the water to pocket and, over the last XX years, formed an oak/rust sandwich over 1 in. thick. The process of rusting absorbs water and oxygen from the air, causing the metal to expand greatly, thus cracking the rims of the cups.

The former steel had turned to a very hard brittle substance resembling a very hard coal. Removing all this corrosion/wood mixture took over one day’s time using a cold chisel and Chuck’s Zip gun. **Eric Gilman** and **Norman Down** sand blasted them to prepare them for the next step.

Equalizer spring cups before and after removing rust build-up.  
Note oak disc under the rust.

On the five cups with the broken sides, **Dean** milled off the remains of the 'sides' and turned a recess around the circumference of the round base. Using a scrap piece of 8 in. well casing, which he found in our scrap, he cut five bands about 2 in. long. These he slipped over the recess, effectively 'clamping' them in place prior to welding because their diameter was just about  $\frac{1}{2}$  in. less than the diameter of the cup. This left a gap of about an inch which Dean filled with a small piece of steel. He welded them with nickel rod.

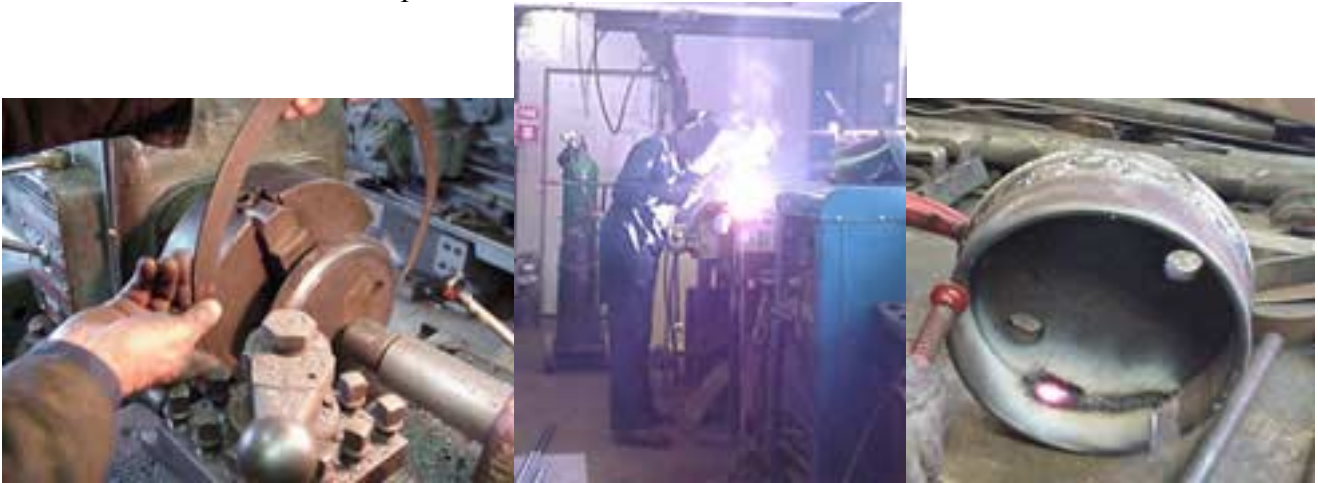
#### Restoring the spring seat cups.

1. Dean checking the size of the groove for the new ring
2. Dean welding the ring in place
3. The finished weld still glowing
4. Chuck drilling out a rusted-in bolt

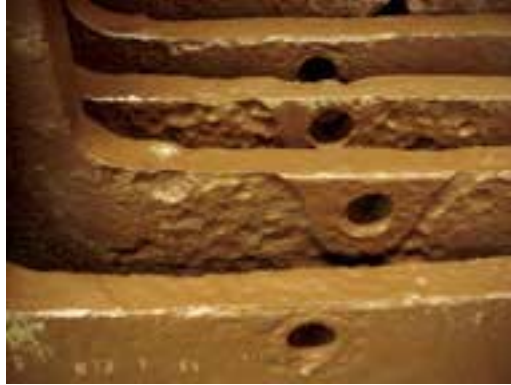
There was one drawback, if you can call it that, to the sandblasting. A C did such a thorough job that removing the rust and 'crud' that had built up on the surfaces of the piece and revealed the true extent of how badly they were corroded. We are examining each piece to determine the extent the pits will have to be filled. Some are being totally replaced, others patched, some filled by MIG<sup>5</sup> welding, and some left as they are.

Pitting around the bolt holes for the spring seats on the equalizer bars

- Equalizer bars (2 pairs) – These are all in good shape with a small amount of corrosion built up at the ends where they seat on top of the journal boxes. When they were returned from sandblasting we found they were badly pitted. We are debating just how much filling should be done but certainly will do the areas around the holes.

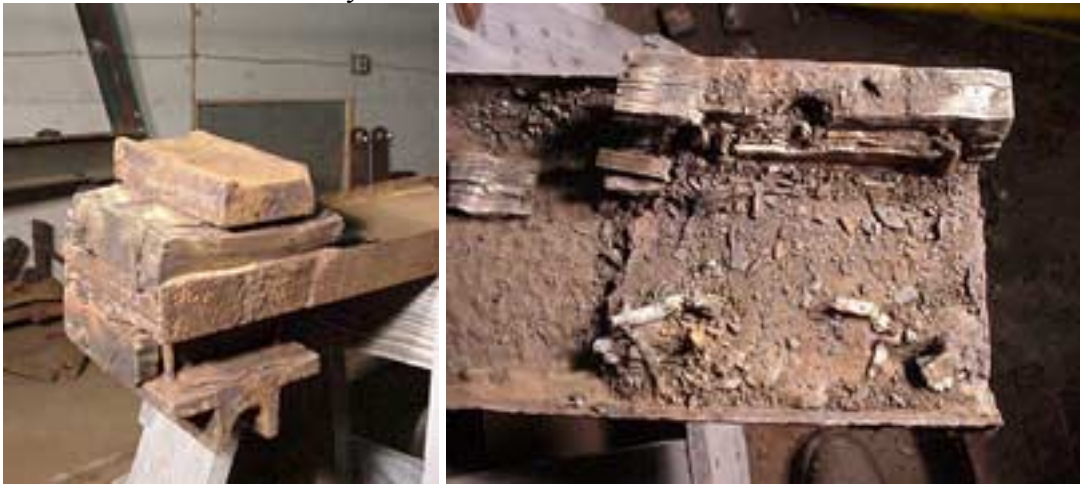
- Spring seats (2) – short heavy casting (channel-shaped) on which the binding strap of each spring rests. From what we have seen, they seem to be in good shape. Beneath that is a short block of oak about 2 in. thick, and 8 in. square. Apparently this is some sort of shim, possibly added as the spring flattens with age. We aren't sure if it was always there.

Spring plank (the channel), spring seat, spacer blocks and lower casting for swing link pin.  
Rusted area after removing block. Stubs of lag screws showing.

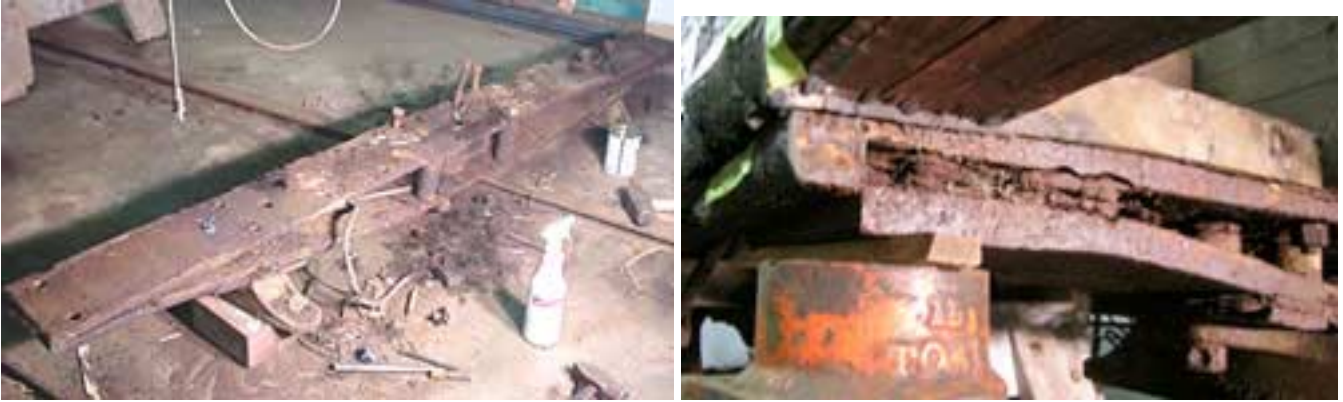
As stated above, the truck bolsters, for the most part, are in very good shape, requiring a minimum of overhaul. However the body bolsters are a very different story. Unlike most cars, those on 100 are out from under the shelter of the body so moisture gets into them and is trapped between the bolster steel and the wood sills. Additionally dirt collects on top of them as well as within them, acting like a sponge to retain moisture. On top of that, the electrical ground return wires are bolted to them. The area around this is badly pitted.

On 4 Feb. we finally took the no. 1 bolster completely apart. As we did this we noticed that the amount of steel remaining about equaled the amount of rust we scraped off. Fortunately the iron castings were not at all subject to rusting and will clean up well. The castings are:

Bolster after removal    Build-up of corrosion between upper and lower plates  
Note the bent-over upper plate.

We figure that we can make new bolsters with some help from Novel Iron Works. They will make the four bends necessary to form the bottom piece. (It is flat on the ends for 7 in. to match the top plate and flat in the center, but 5 ½ in. lower, for the center bearing.) On 5 February, **Randy** took the bottom plates to them so they can put in the proper bends. I have just gotten off the telephone with Novel's draftsman who is making a CAD drawing for their shop to do the bending. I also said that the original was so badly corroded that it was very difficult to get solid dimensions from it but we figured out what it should be.

We asked Andy Cole if they could bend the top plate back on itself as Laconia Car Works did, but he said they didn't have the equipment to do it. So we will weld a block to the bottom side of the top plate to give the same effect as well as hold the bottom section in line. Novel will also punch the 2 1/8 in. hole for the king pin.
