**Atlantic Shore Line Locomotive 100**  
**Curatorial Report No. 6**  
19-31 March 2007  
by Donald G. Curry, Interim Shop Manager

Seashore Trolley  
Museum  
Locomotive 100

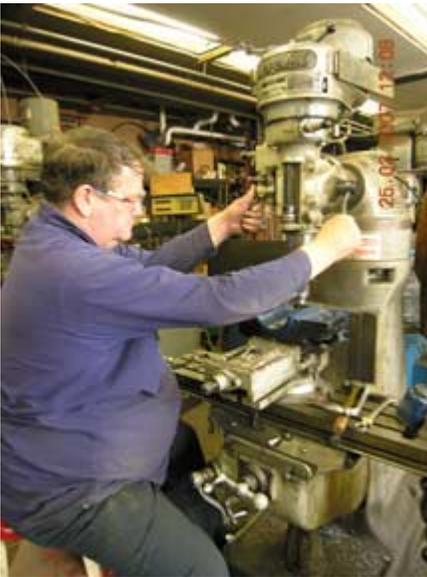
Chuck milling out dowel pins

Bearing caps – These have 5/8 in. steel dowel pins to keep the bearing shells from rotating within the bearing cap. Over time they have worked back and forth causing the pins to wear from round to oval, thus allowing the shells to rotate even more. **Chuck** drilled and milled the old pins out; then **Dean Look** installed new ones.<sup>1</sup> Because the holes in the bearing caps were of various depths, Dean had to grind some that stuck in more than the 5/16 in. called for in the bearing blueprints. The bearing caps will go back to A.C. for the assembly and final testing of the motors.

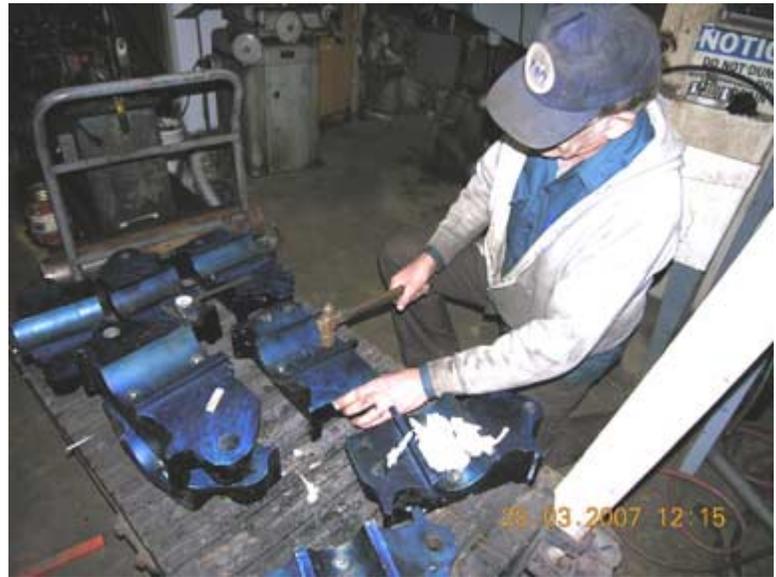
Dean driving in new dowel pins

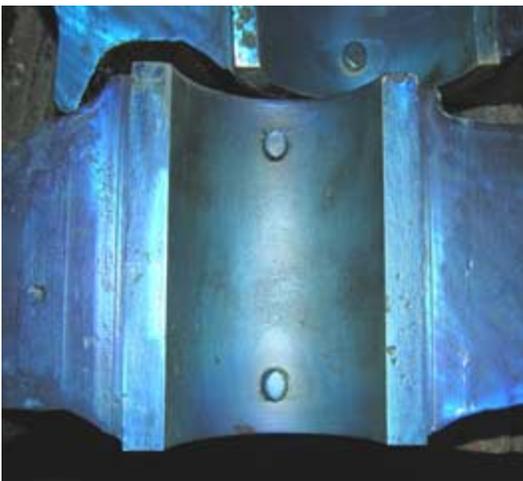
Beat-up dowel pins

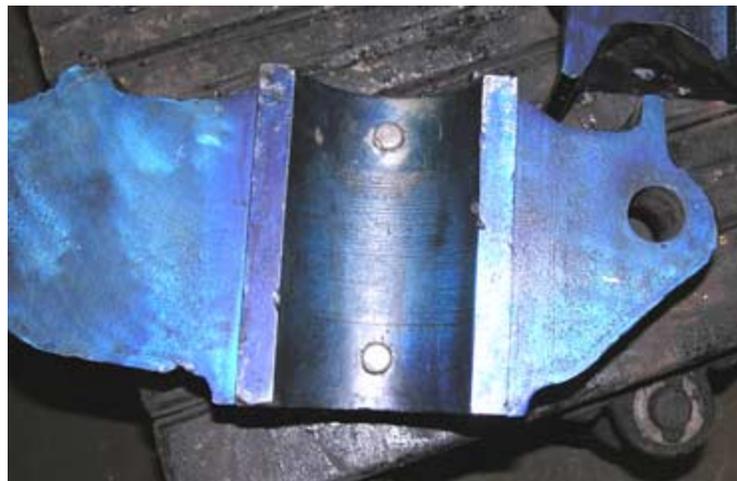
New dowel pins

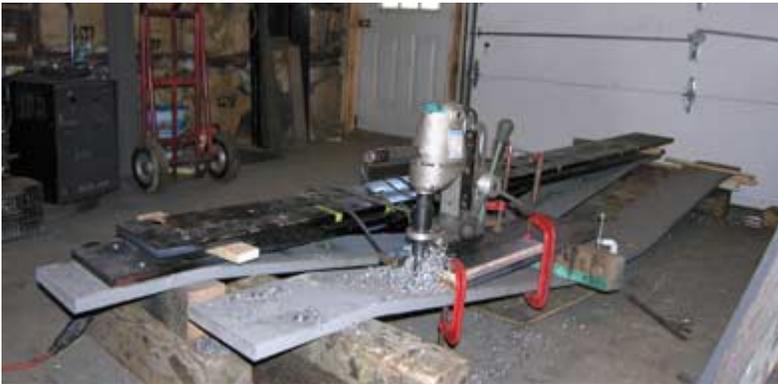
**Body bolsters** – The first job on these was to set up the 1 x 8 in. (read very heavy!) bottom plates for drilling. A previously drilled top plate was clamped top of each one and the 13/16 in. *Rotabroach* was run down through into the lower plate. This worked well most of the time but on one hole, despite the strength of the magnetic base of the drill,<sup>2</sup> it broke loose at a hard spot in the steel. Because the drill was already in more than 1 in., it had no lateral ‘give’ and snapped. So we quickly ordered another, this time carbide-tipped to cut through the hard spots and just started the hole in the 1 in. plate to mark it; then slid the upper plate to the side and successfully completed the drilling.

**Drilling body bolster with *Rotabroach***

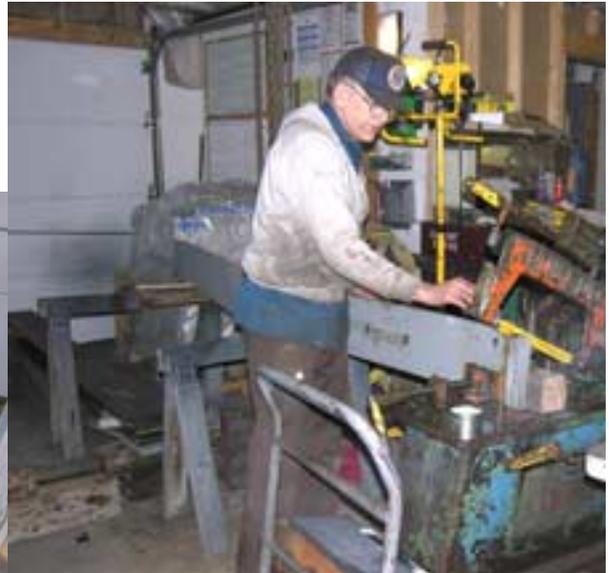
**Dean cutting off end of lower plate.**

First we had to cut off excess length from the bottom (bent) plate. We rapidly discovered the capacity of our tools was not up to that. The small horizontal band saw would take forever and wouldn't cut straight anyway. It would be difficult to hold a piece in the vertical band saw, which also wouldn't cut very straight. The abrasive cut-off saw would go through a stack of blades before all four cuts could be made. However we still had the old fashioned Toledo reciprocating hack saw.<sup>3</sup> It looked large enough and was certainly heavy. We were disappointed to discover it wouldn't cut anything over 6 in. wide—but **Dean** came to the rescue saying that we could do it half-way through on edge; then turn it over and do it the rest of the way—which he did. The surplus blocks were then cut into the pieces to form the hooks, one of which Dean welded into place. It will then be ground to a half-round cross-section, duplicating the appearance of the original.

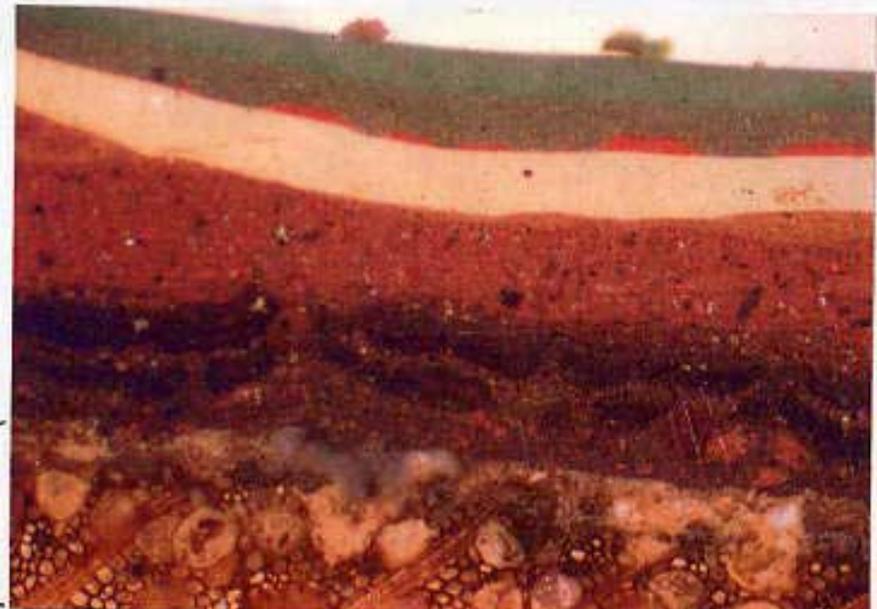
①

Sample #1. Only bits of the original dark treatment survive. This was followed by a medium gray which appears to be a base layer. There follows two treatments which appear as very dark browns in cross section and may appear black when isolated and matched. Both were given clear finishes. They were followed by a red brown, then recent treatments.

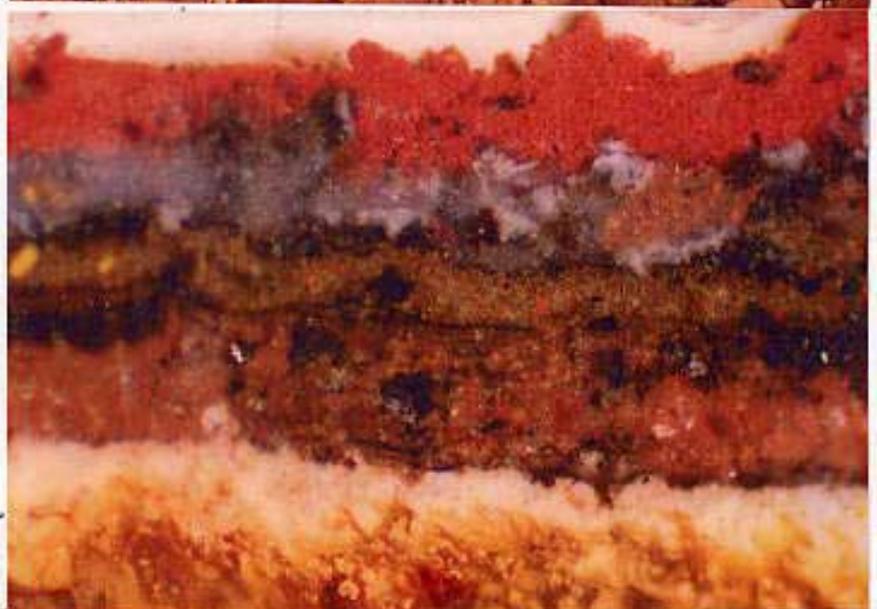
②

Sample #2. This sample starts with (what would probably be if isolated and matched) a rosy tan, followed by two red browns, a greenish brown or brownish olive, then recent treatments.

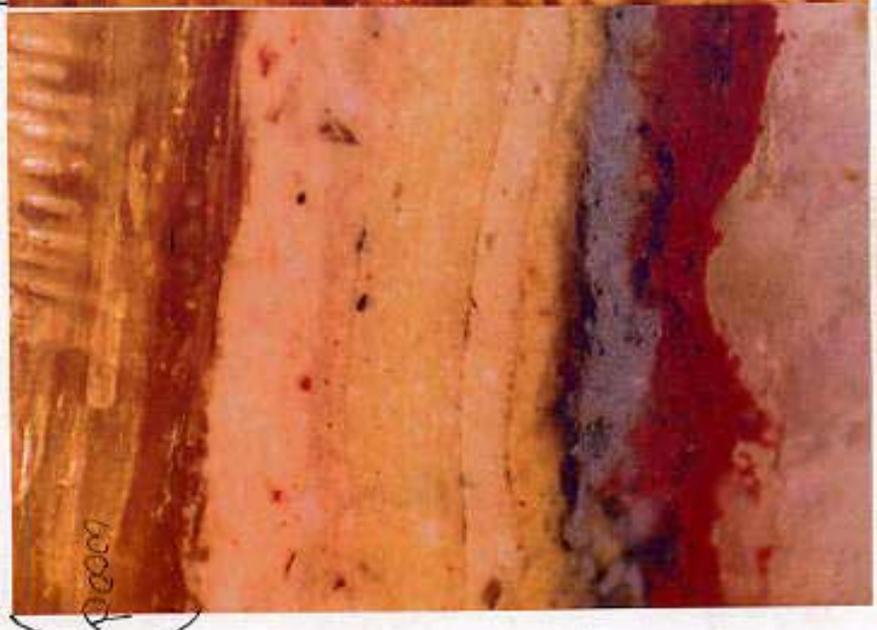
③

Sample #3. This sample begins with a rosy tan which is probably a match to the first treatment of sample #2. It is followed by a yellow, a light tan, a mustardy yellow, then recent treatments. (Again, these are the colors as they appear in cross section.)
