## Atlantic Shore Railway Locomotive 100

Curatorial Report no. 12

24 May – 23 July 2008

by Donald G. Curry

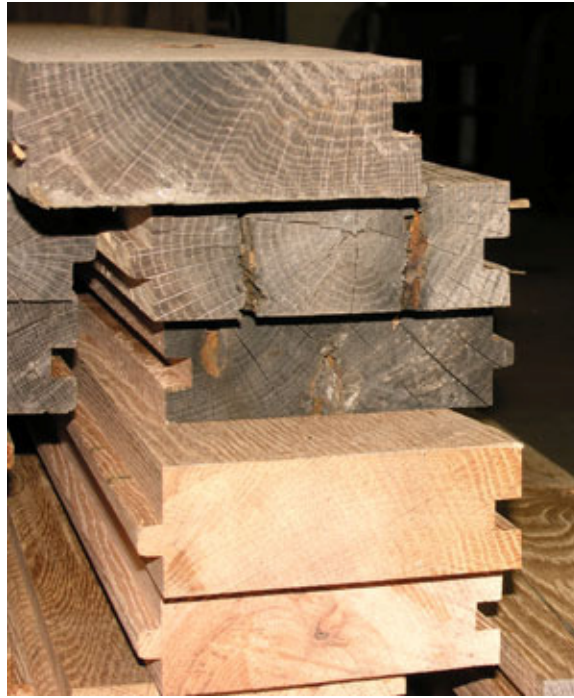
The actual measurement of the 'new' flooring turned out to be 1 ⅞ in. thick. As was common in flooring the upper section above the tongue was thicker to allow for wear 13/16 in. vs. 9/16 in. below. Following Laconia's practice, the pieces have face widths of 4 ⅝ in. up to about 8 in. with the majority being 5 ⅝ in.

“New” recycled oak decking

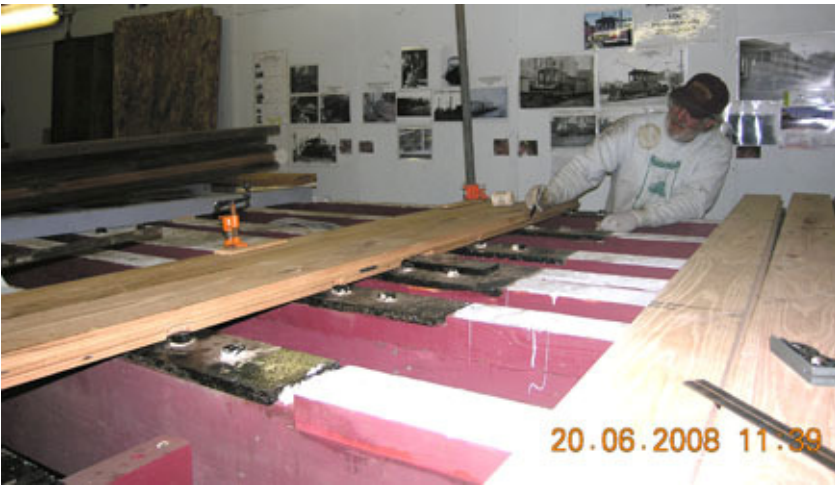
Phil Morse proudly showing off his 'notching' work.

After the boards were laid out, they had to be fitted over the bolt heads and reinforcing plates over the bolster. Phil did this using a skill saw, drill press and chisels so the boards all fit down level. He was able to use them to the full length, avoiding any splices in the middle.

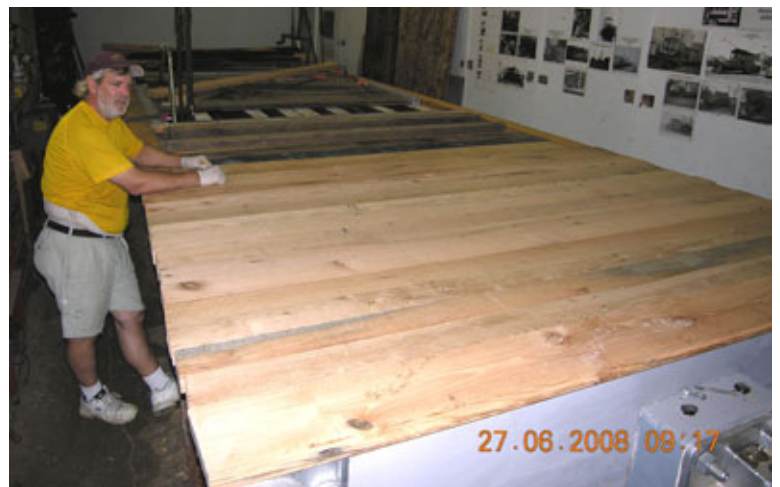
No. 1 end deck fitted

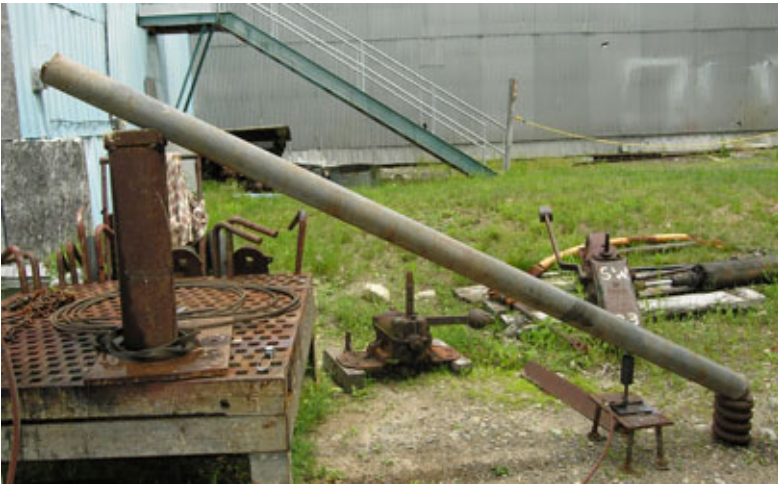
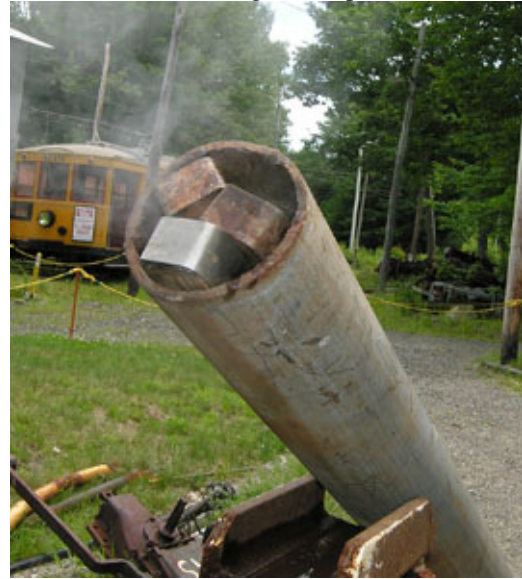
Softening arches prior to bending.

The form was simply 1 ½ in. scrap wood blocks about 6 in. long, screwed to the OSB. We don't have a good source of steam so we boiled the wood. Bernie Bisnette welded a cap to the end of a piece of 4 in. steel pipe 10 ft. long. This was then propped up at about 45 degrees and a propane burner placed under it near the bottom. The tube was filled with water and heated for about 1 ½ hrs. (based on a rule of thumb of 1 hr./inch thickness) We had to maintain a small stream of hot water coming in to replace what was boiled out.

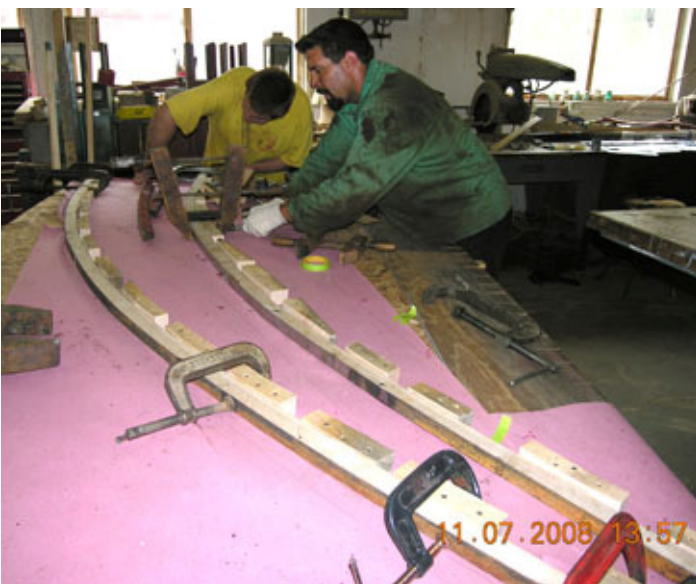
Technicians Chris Skulsky and Bernie Bisnette bending arches.

After boiling, the wood was quickly removed, pulled around the form and clamped in place where it was left overnight. When removed it sprung back a significant amount but when clamped to the cab, it pulled into place with a nice curve. When the tension strap was removed there was no breakout on the outside of the curve.

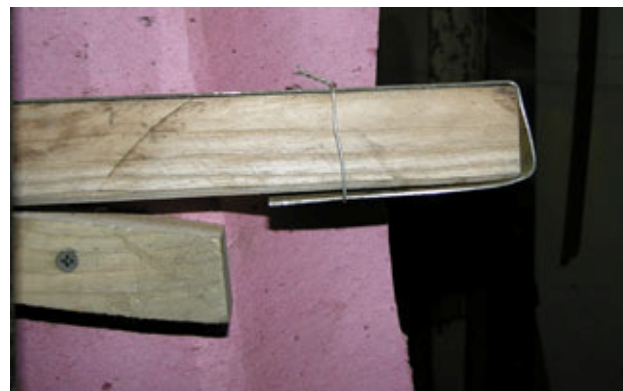
Tension straps around end of arch wood.

To prevent the outside (convex) of the piece from breaking out as it was bent, a tension strap was made of 14 gauge steel about 1 ¼ in. wide, about 14 in. longer than the arch piece (which was also about 2 ft. longer than necessary for leverage when bending). The strap was then bent around both ends and held in place with a wire. It was also wired in the middle to keep it in place while being soaked. The center of the piece was marked for location on the bending form.

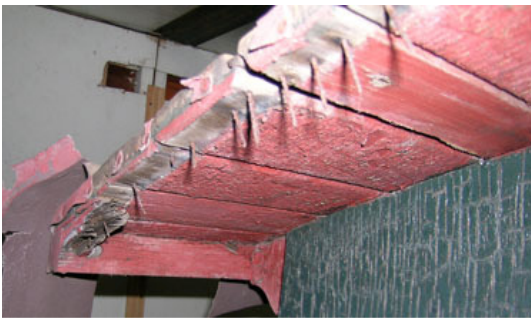
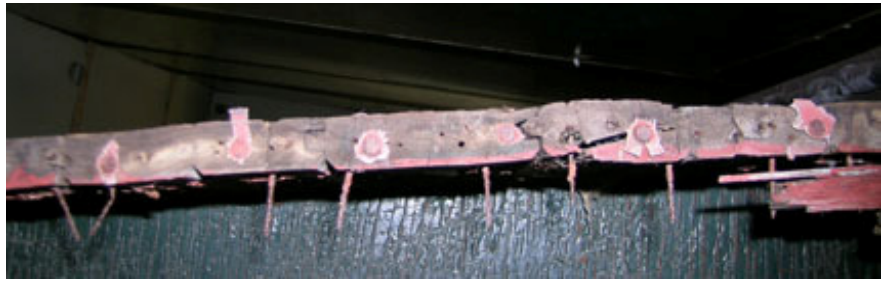
As we were removing the arch we noticed two sets of nails driven into the ends the tongue-and-groove roof sheathing. One set was the tacks that held the Seashore-applied roof canvas. The other was 4d (about 1 ½ in. long) common nails with no obvious purpose. After some thought we realized that these had held a long-missing half-round wood trim that was over the edge of the canvas and extended around the entire periphery of the roof. It must have disappeared during the Seashore re-canvassing and the nails simply driven flush. The moulding is quite prominent in most of the older photos so it can be duplicated. It appears to be about 1 in. wide and about ½ in. thick. We will make this from ash using the router.

Now missing roof molding on 1907 photo of 100.

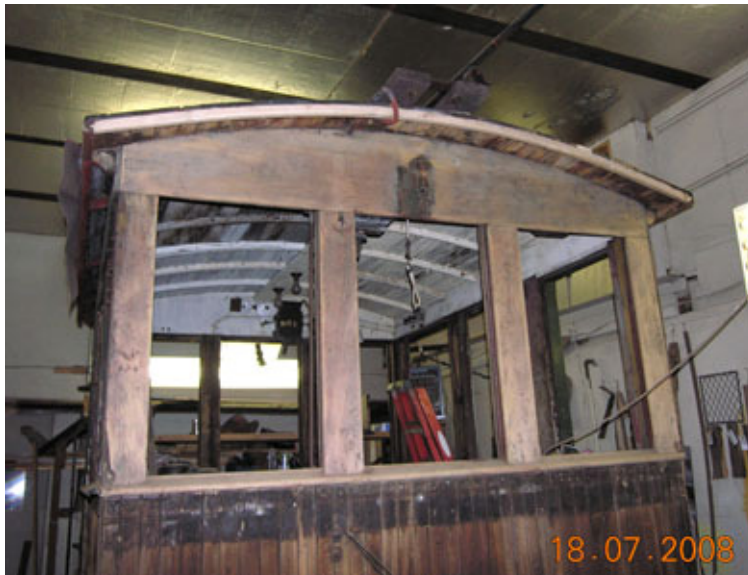
The ends of the tongue-and grooved roof sheathing which is 13/16 in. thick, particularly the no. 1 end, were split so we dribbled West System epoxy into them to fill the splits and keep them from growing. There was only one small area (3 x 8 in.) which required replacement.

No. 2 cab end with new arch. Stripped and ready for priming.

To fasten the arches we are using 1 ¾ in. galvanized ring nails. In order to keep them from bending it was necessary to pre-drill. Ultimately entire roof will have to be re-nailed.
