**Atlantic Shore Railway**  
**Locomotive 100**  
Curatorial Report no. 10  
14 January – 2 February 2008

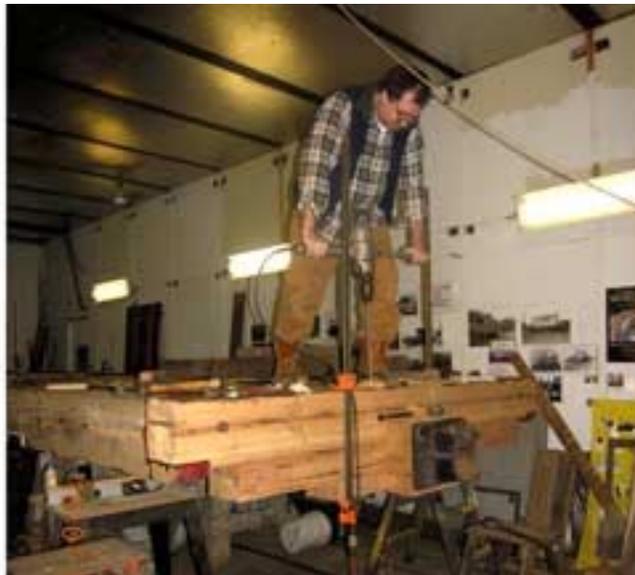
Randy Leclair using the big drill to make holes for bolts to fasten sill assembly together.

The car body bolsters, now firmly bolted into place, projected out to the side. First one end of the sill was set on, then the other, carefully maneuvering it right to the end of the bolster. Then, drilling up from the bottom with the long 13/16 in. drill, holes were made for the 3/4 in. square-head bolts that constituted the first anchors for the sills. After all was done there were 10 bolts on each side holding the sills in place: two at each bolster, two at each needle beam and one at each end. Every joint is caulked with *Phenolseal* almond colored adhesive caulk.

Randy was the 'heavy' in the drilling 'department'. We used a very big old Craftsman drill which had no trouble turning the 13/16 in. drill. However, despite its age (at least 100 years), the SYP was full of sap. This tended to make the chips from the drill stick to it and plug up the hole. In fact, on several holes we had to run the drill all the way through; then 'unchuck' the drill and remove it from the bottom. The holes were still filled with jammed chips so they had to be forcibly driven out with punches and re-drilling. We discovered that spraying "P.B. Blaster"<sup>4</sup> on the drill was quite helpful. Several people including Dean Look & Bob Reich commented on the scent of pine that wafted out of the box during this operation!

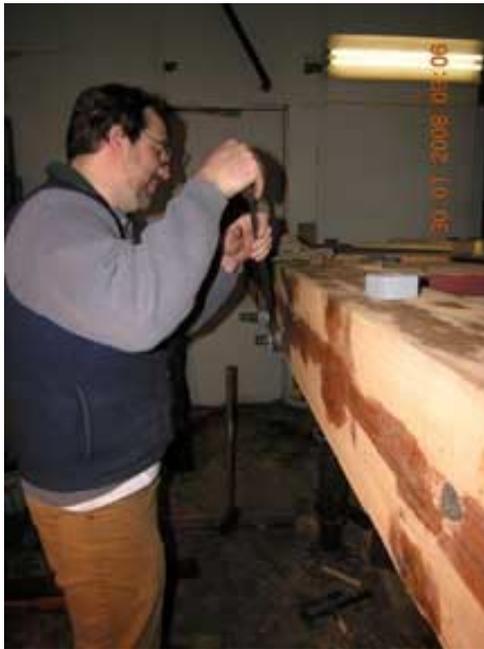
Randy tightening bolts on no. 2 end.

**The giant clamp** - The next morning we devised a giant clamping system to get the sill on the rest of the way. There are four 1 ¼ in. round rods running from end to end of the car and out through each end sill. The ones on the corners are bent down in the center of the car and come out at each corner through the pole pocket casting. In the center are two others (between sills 3 and 4 and 5 and 6). These are straight from one end of the car to the other and serve as the major anchors that hold the couplers and take the strain when 100 pulls a freight car. Because the side rods are bent somewhat U-shaped, it was impossible to have them exert any tension at this point.<sup>5</sup> However the straight ones can be used to create lots of tension. On the no. 1 end, they are passed through the two 1 ⅝ holes drilled through the sill about 2 in. above the bottom. Then large flat washers and heavy hex nuts are put on and the rods pushed right against the sill. On the no. 2 end, a large plate with two holes was put over the two rods; then pipe spacers are put over the rods followed by nuts and washers. Now when the nuts are tightened, they will exert tremendous force on the sill forcing it to pull up tight into place, which they did very nicely.

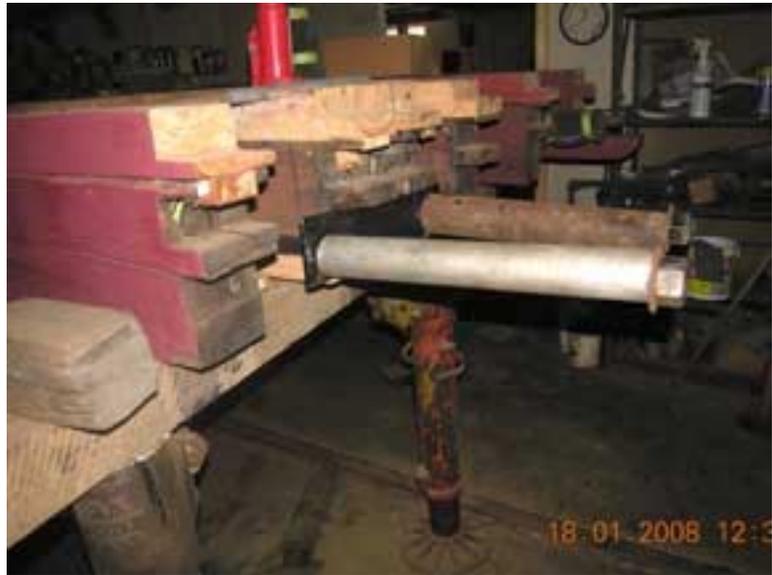
The anchors on the no. 1 end, 31 feet away.

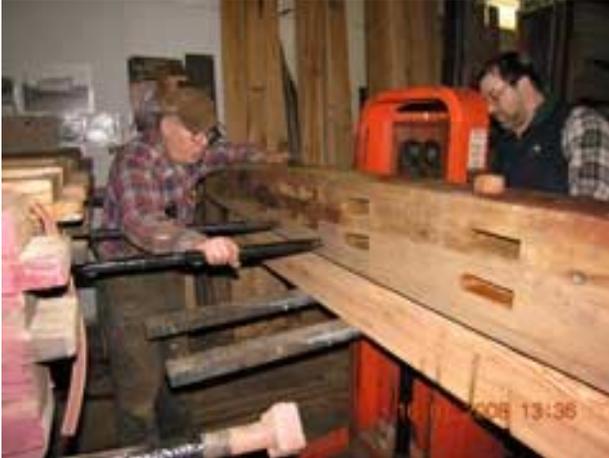
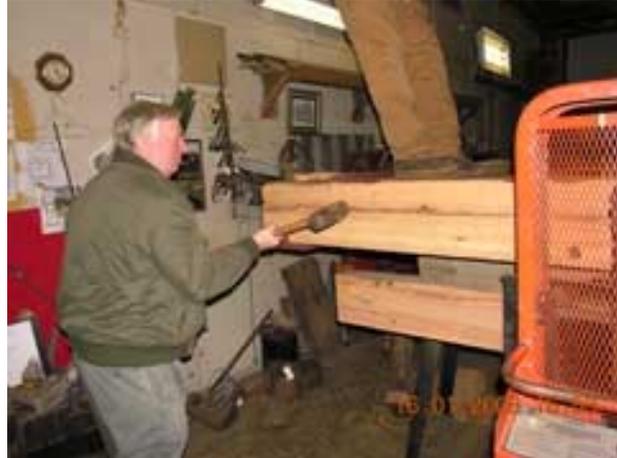
Donald Curry & Randy Leclair lining up the through-bolts to go through the end sill.  
Norman Down giving a little help to getting it in place.

**Big blocks** – The next task under each end sill was to fit the big square x 84 in. pilot support blocks and under them the thinner block that contains the lower coupler mounting bolts (1 ¼ x 17 in.) These plus the end sill form a giant 3-decker “sandwich” which provides the support for the coupler and the pilot. This whole assembly is held together by eighteen ¾ in. specially made square head bolts of various lengths, depending on how many layers they go through.

In the middle front of this assembly is a block made of two 6 x 6 (approx) x 16 ¼ in. SYP blocks. The long rods go through two holes in the top block and the two long bolts go through the bottom two. The assembly also is held together by two vertical bolts. In front of all this is the heavy cast steel coupler mount, held by the hex nuts on the through-rod and bolts. The lower bolts also go through two wrought steel angle braces behind the pilot block with two bolts in each going up through sills 4 and 5 and reinforcing plates dadoed into those sills.

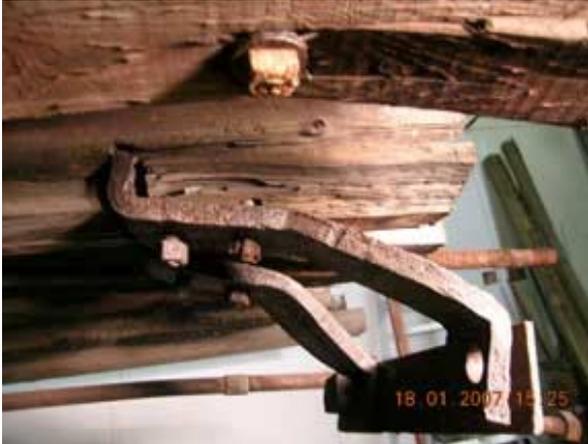
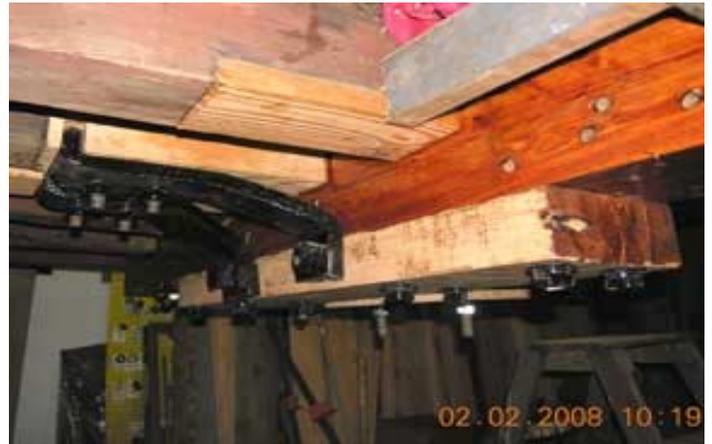
Coupler mounting brackets before and after

**The couplers** – are held on by the two center through rods and two 1 ¼ x 17 in. home-made square-heads under the sills and projecting out through the bottom layer of the end 'sandwich'. They hold a pair of Laconia-forged brackets which, after sandblasting, turned out to be in perfect condition. It is interesting to follow the grain of the metal in them and in the bolts indicating how they have been forged. The heads of the bolts are nuts held on by peining over the end of the rod. The coupler mount is spaced out from the end sill, thus clearing the pilot, by a pair of 6 x 6 in. (approx) x 16 ¼ in. blocks, also held by the same bolts. There is also a pair of vertical bolts holding the two together. To these bolts attach heavy steel straps (about 2 x ½ in.) which appear to be some sort of brace for the coupler.<sup>8</sup> Both of these were quite badly before we started on the project. Very likely they caught on the ties as they hung so low, which caused them to be bent back on themselves.

The coupler mount is a heavy (about 100 lbs.) steel or malleable iron casting with a hole in each corner for the above rods and bolts. Both mounts are in good condition, only requiring sand blasting and painting. The knuckle assembly and pins have yet to be assembled.

This morning we installed the first set of coupler mounting brackets under the no. 1 end. Then the long bolts were pushed out through them and the wood coupler mounting blocks. When we went to put the actual coupler mount on we discovered it wouldn't fit. The spacing on the two bolts and two rods, which should have formed a rectangle, didn't. We used a small (4-ton) hydraulic jack between the top rod and bottom bolt to push the bolt down, which it did but not quite enough, so we will very likely have to heat up one or both bolts to get bend them slightly.

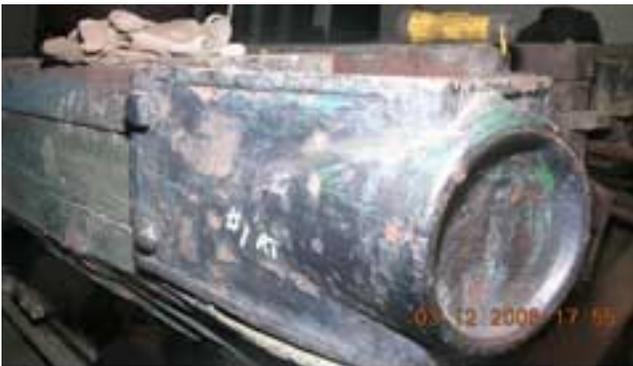
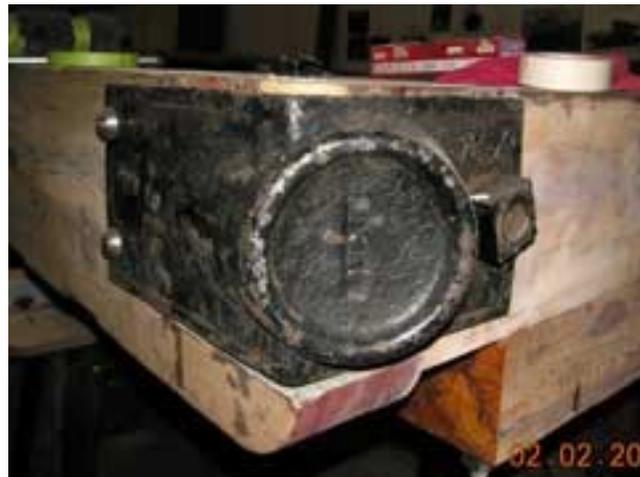
Poling pocket before and after. (Still to be blasted and painted)

**Poling pockets** – On each corner is the poling pocket, used for pushing a car on an adjacent track to the one on which the locomotive ran. They are made of malleable iron or cast steel and have become slightly bent over the years. Dean straightened them out and welded in a patch where a chunk was missing. (Try and find which one it is!) The front surface has the hole for the truss rod and the side surface has holes for two special round-head bolts. We would not have known this detail except fortunately one rather rusted original one remained.<sup>9</sup> Dean fabricated new bolts with the special high round head by taking a  $\frac{3}{4}$  x 6  $\frac{1}{2}$  in. square-head bolt, turning it round and then adding weld to give it enough material to turn to the proper shape in the lathe. For that he ground a special rounding-over tool.

The original bolt was not quite a carriage bolt in that it did not have the square under the head to keep it turning in the wood. To do this, Dean welded on a small lump so, when the bolt is driven into the hole in the wood it won't turn.

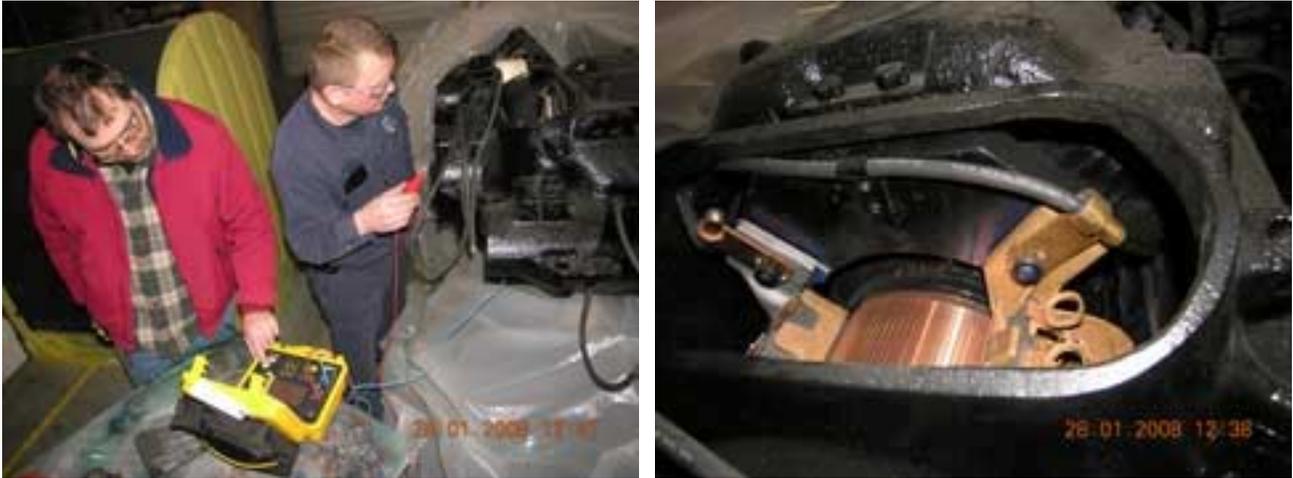
Randy Leclair monitoring the new AEMC 1060 megohmmeter while Roger Paradie makes the connection to the overhauled GE 80 motor at A. C. Electric

**The traction motors** – As part of the recent visit to A. C. Electric, we were interested in the insulation resistance of 100’s four GE 80 traction motors, which are now completely overhauled. They are in storage there because we do not have a good place and will very

likely remain there for another year until the second truck is done. Using our new AEMC 1060 megohmmeter<sup>12</sup> we tested the insulation and came out with an amazing 2.5 gigohms! That's 2,500 megohms or 2,500,000,000 ohms! (Have I got the right number of zeros?) We were rather pleased that it would measure that closely.

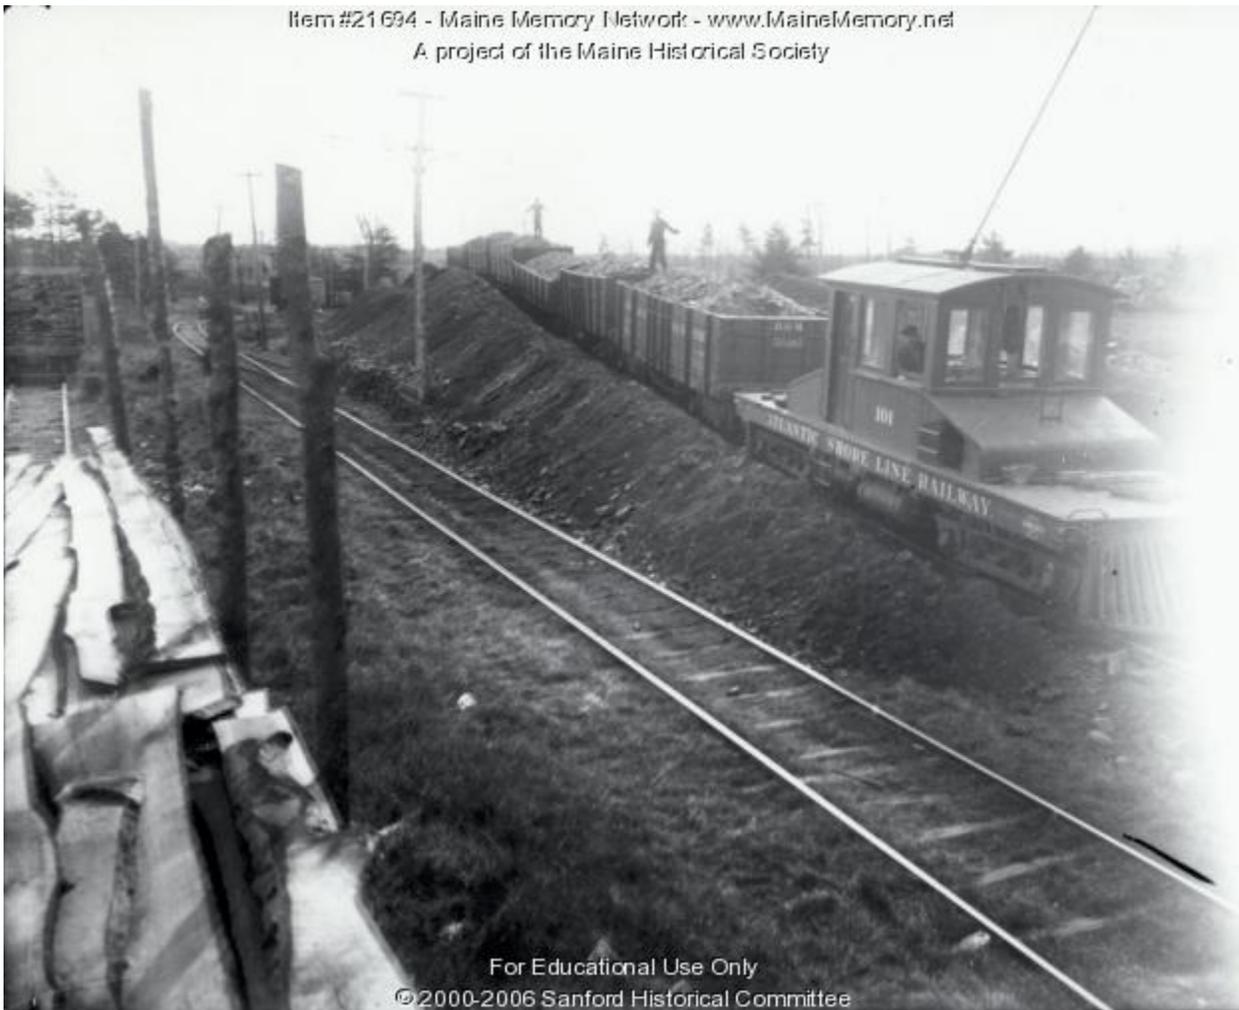
If you look very closely you will see this is actually 100's sister locomotive, no. 101. That makes this photo even rarer for two reasons. First it shows the coal hauling operation in progress and secondly it shows 101 in its extremely short lifetime as a steple cab. (Nov. 1906 until some time in mid 1908, when it became an express car, giving up its cab to 102.)

Another thing is the weight that this very small and very light (there were no counter weights in these locomotives) was pushing up the rather steep grade. There must have been a lot of spinning. We wonder what sort of 'run' they had to take and what was going on inside its K-28 controller. How did those two men on top of the cars maintain their balance in the 'run'? Was the nearer guy relaying a 'stop' message from the further one? Did they stop in time?
