Atlantic Shore Line Locomotive 100
Curatorial Report no. 11
14 January – 25 February 2008
by Donald G. Curry

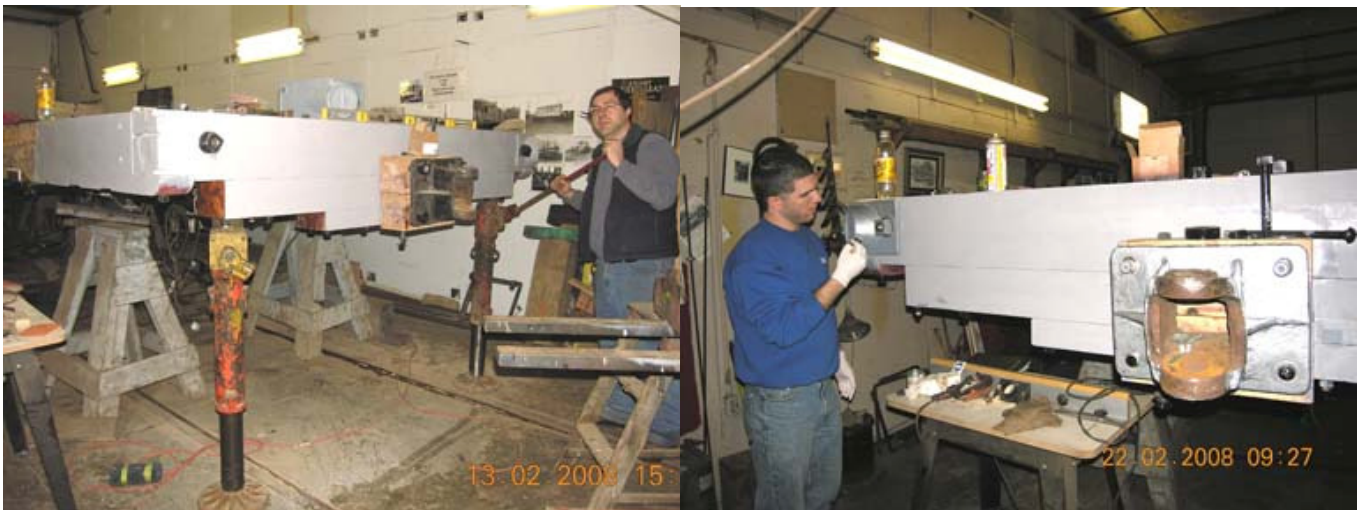
Up into the air - well not really. But with deck and associated framework now complete and it was necessary to raise it about a foot higher so we can work comfortably (?) under it to install the under-body equipment. This was accomplished with **Randy Leclair's** help using the very useful screw jacks that are even older than the car they're lifting. Their big advantage is they're high with fairly large round bases so they're stable. We easily lifted the deck about a foot and repositioned the car body horses under the side bearings of the steel body bolsters. This makes more working height under the car and gets the horses further out toward the end of the car where we need the area to work. We were trying to estimate the weight of what we were lifting and came out with about 3 tons. Does that sound right?

Randy Leclair raising the frame to new Heights.

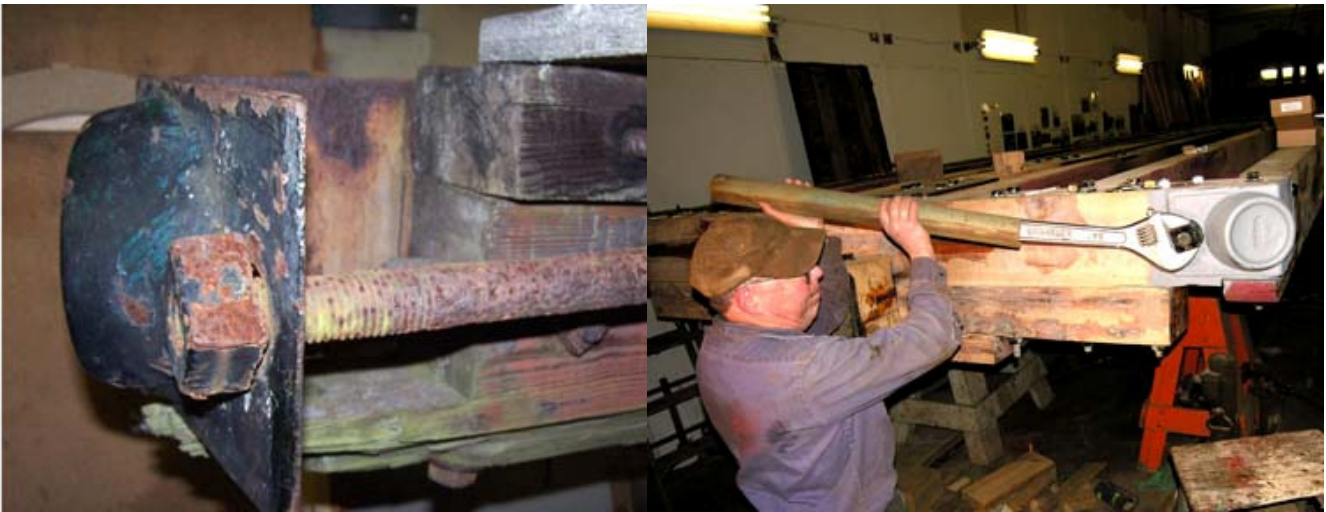
These were removed last summer, scraped and painted with *Chassis Magic* black and *Awlgrip Super Jet Black*. The threads on each of their ends were quite beat up and had to be filed and ‘chased’ so the square retaining nuts would screw on. These threads must have been to some antique standard because a standard die wouldn’t go over them. **Dean Look** carefully reshaped them with a file.

Truss rod ends before and after.

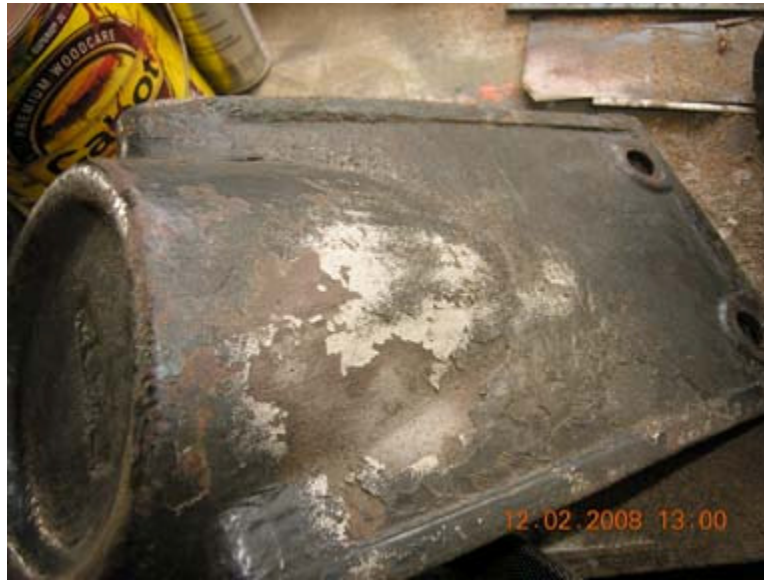
Norman Down and **Lloyd Rosevear** sand blasted and painted them. In the colour scheme we are planning to use on 100, the pockets were painted in aluminium. As they were scraped many traces of that colour were found under the latter day black.

Pole pocket showing aluminium paint under the black.

One of the pocket castings had a significant chunk that had been broken out years ago. With his welding skill **Dean Look** pieced in a piece of steel and we defy anyone to find which one it was.

On the front side is a large hole for the truss rod. On the side are two holes for the bolts which go through the side sill. When we took the car apart the pocket castings that remained on the car were fastened with both round head and square head bolts. It was obvious that the original was the round head, something that Laconia Car Company had made themselves. **Dean Look** took some $\frac{3}{4}$ x 6 in. square head bolts, turned the heads round and built them up with welding, made a special cutter; then turned them to the proper 'antique' shape. Unnoticed is a trick he used so they wouldn't turn in the hole: welding on a blob that would cause it to stick in the hole without rotating as it was tightened.

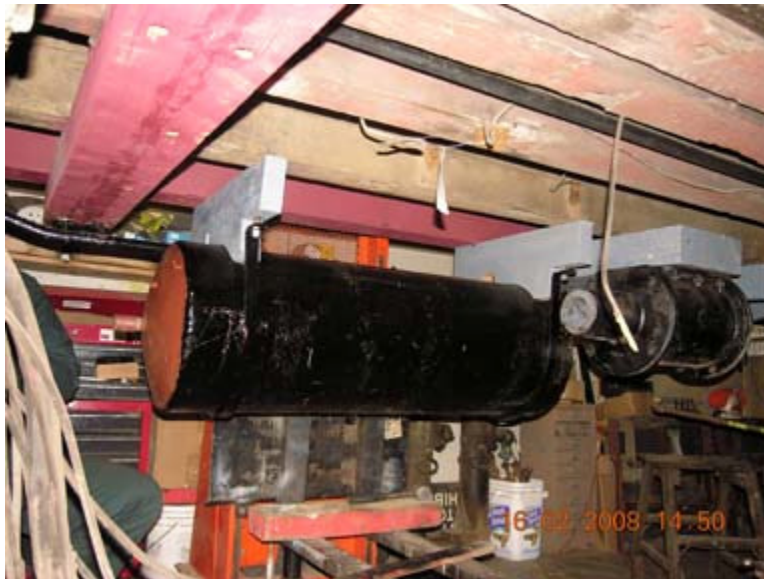
Brake cylinder – Like most cars of its period, 100 has one brake cylinder: 10 in. diameter made by New York Air Brake Co. of Watertown, NY. **Chuck Griffith** and **Dick Avy** have disassembled and cleaned it, replacing its leather piston cup with a newer one of neoprene rubber. They tested the cylinder and found it leaked only very slightly.⁷

The cylinder is mounted on a very large oak block about 5 in. thick and 16 in. wide which, over time, had developed a number of splits. However because of its size, we pulled it together with clamps, filled in the gaps with wood and applied epoxy filler to the remaining spaces. It is now as strong as new and holds the cylinder up against the bottom of sills 1 and 2.

Auxiliary reservoir no. 1 and brake cylinder mounted under 100.

The auxiliary tank, made in 1999, looked quite good, seemingly requiring some minor scraping. However outdoor storage, under snow had done its dirty work and, with every stroke of the carbide scraper showed more and more rust pockets, so it was necessary to sandblast the entire tank. (Fortunately it fitted easily in our sandblast cabinet.) **Dean** and **Chuck** ground off its mounting brackets so the tank could be mounted with the traditional $\frac{1}{4} \times 1 \frac{1}{4}$ in. straps (bands). The tank was then primed (with Fine Paints of Europe's gray primer) and given a coat of Super Jet Black *Awlgrip*. When it was mounted we made sure the modern label was on the inside where only the car inspectors could see it.

To 'hang' the tanks on the locomotive's right hand side required the use of the battery fork truck. With **Chuck's** assistance and lots of tweaking and trimming on the mounting blocks main reservoir tank no. 1 went up as did the auxiliary reservoir. (For some reason the mounting straps couldn't pull up tight against the notches in the mounting blocks despite their being copied exactly from the originals.) However they are quite solidly mounted being 'nestled' in the curve of the mounting blocks.

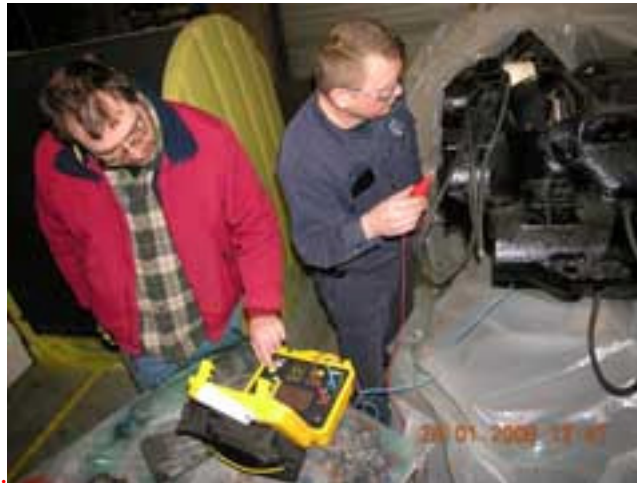
Motors- Randy and I paid a second visit to A. C. Electric in Auburn, Maine, partially to introduce him to what they can do and to check out the status of the various motors they have. 100’s motors are done and wait our ability to install them. We had asked Roger Paradie to place one outside overnight to see what happened to its insulation resistance. He did that, but it’s not the time of year when much, if any condensation forms. With our new AEMC 1060 megger, we checked the resistance of all four motors and it ran up to 2.5 gigohms at 1,000 volts!! With our other megger that would have registered at infinity.

Roger Paradie preparing to test the insulation resistance of one of 100’s motors at A. C. Electric Using STM’s new AEMC 1,000 volt megger.

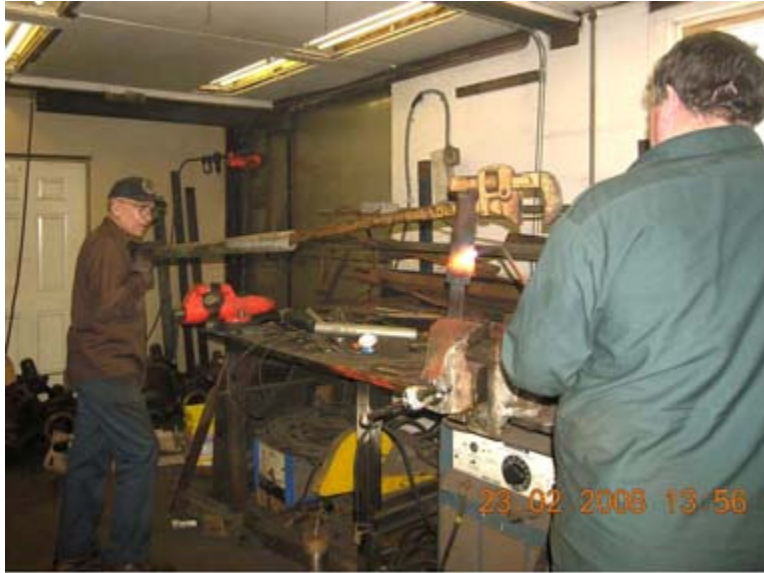
Bent brake levers – At some time during its Seashore life, the air compressor governor stuck and the system over-pressured breaking off two truck brake levers and bending two of the turnbuckle-style slack adjusters (and an end of one of them). **Dean** and **Chuck** were

If it doesn't work the first time get a hotter torch and a bigger hammer.
Dean and Chuck loosening up one of the truck turnbuckles.

applying lots of heat, sledge hammers and a mighty 8-foot pipe wrench arrangement to break the clevises on the turnbuckles free. Using the hydraulic press they straightened the screws so things are almost finger-tight now. They have started making new brake levers from $\frac{3}{4} \times 3 \frac{1}{2}$ in. plate. First they drilled the three holes in each for the pivots and pull points. Next they will have to mill them to shape.

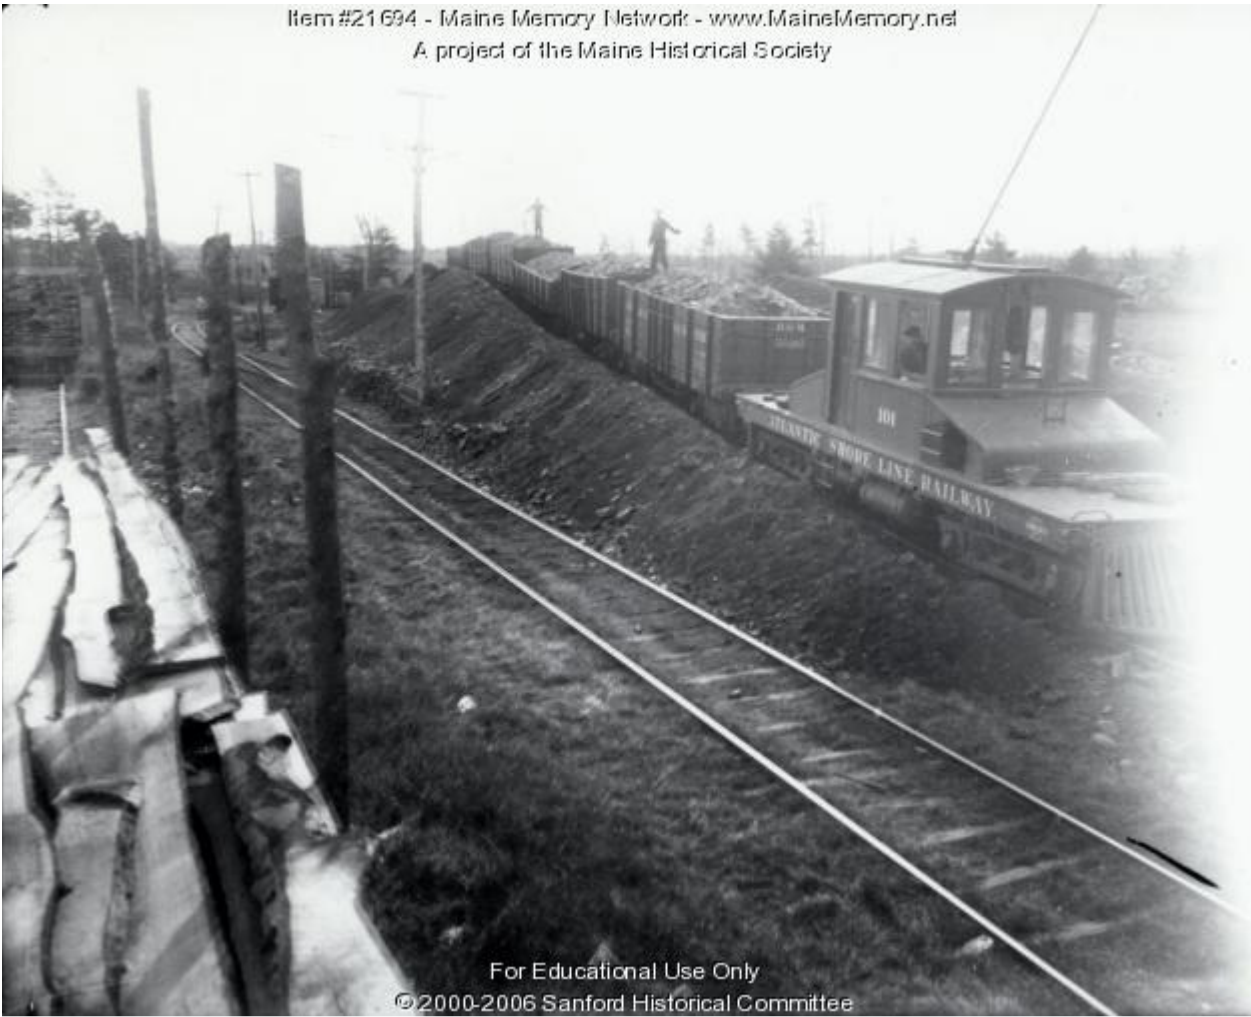
Item #21694 - Maine Memory Network - www.MaineMemory.net
A project of the Maine Historical Society

A new photo turns up – A very interesting photo turned up on the Maine History Network's (Have I got the right name?) website. Thanks to **Mike Simonds'** watchful eyes. While it doesn't show 100 it is the only view we have seen of sister locomotive 101 in its original form before being made into an express car in 1908. Further it shows 101 pushing six fully loaded gondola cars of coal up a steel ramp in Springvale. Possibly this coal was from the Cape Porpoise coal pocket or even directly unloaded from coal schooners at the Cape Porpoise pier. We are wondering how they made it up that grade. There are no weights in the locomotive to give it more traction and its K28 controllers must have taken quite a beating! We note the two men standing on the load. Was the one in the distance relaying 'stop!!!' to the nearer one who would then yell to the engineer?
