**Atlantic Shore Line**  
**Locomotive 100**  
Curatorial Report no. 3  
17 January – 5 February 2007  
*by Donald G. Curry, Interim Shop Manager*  
Seashore Trolley Museum

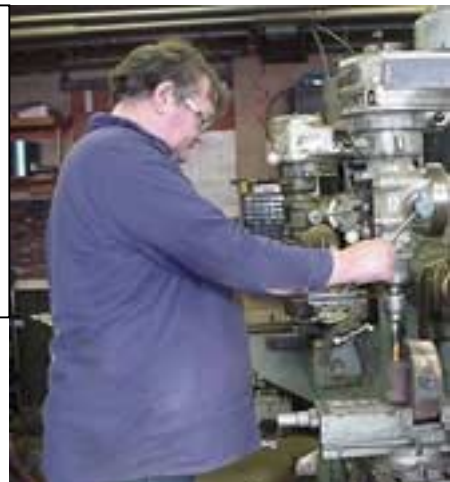
#### Restoring the spring seat cups.

1. Dean checking the size of the groove for the new ring
2. Dean welding the ring in place
3. The finished weld still glowing
4. Chuck drilling out a rusted-in bolt
